Manhole Inspection Summary

Manhole # S53E__025MH

Insp Date: **12/23/08 10:14 AM**

Location Address: **rear 148 s east av**

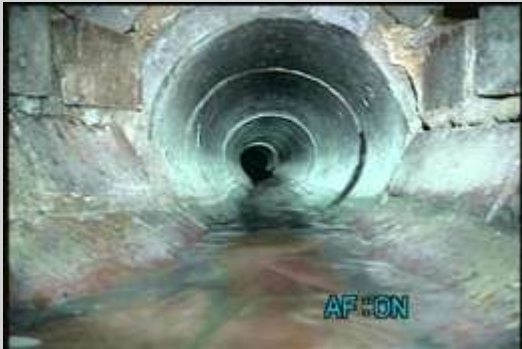
12 O'Clock Outflow

8 in. Circular Gravity Sewer
Pipe Out @ 12 O'Clock

Pipe Material: **Clay** ☐ Pipe Lined

Invert Depth: 7.75 (ft.) Flow Characteristics: **Fast**

Infiltration: **None** Pipe Seal Cond: **Unknown**

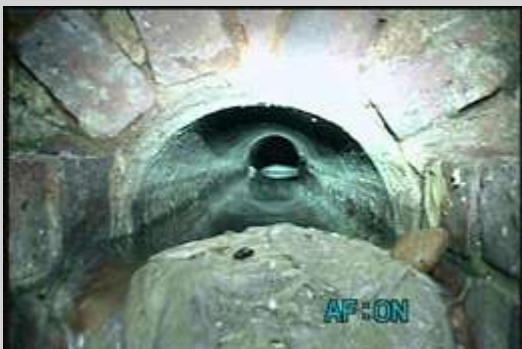
6 O'Clock Inflow

8 in. Circular Gravity Sewer
Pipe In @ 6 O'Clock

Pipe Material: **Clay** ☐ Pipe Lined

Invert Depth: 7.50 (ft.) Flow Characteristics: **Slow**

Infiltration: **None** Pipe Seal Cond: **Unknown**

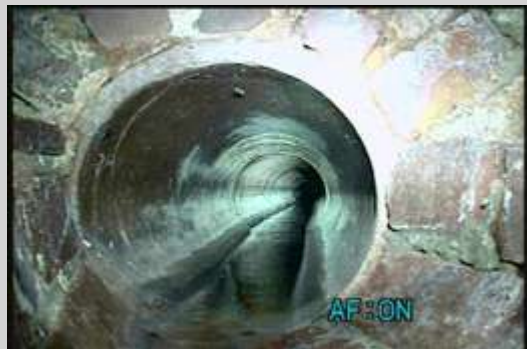
9 O'Clock Inflow

8 in. Circular Gravity Sewer

Pipe In @ 9 O'Clock

Pipe Material: **Clay** ☐ Pipe Lined

Infiltration: **None** Pipe Seal Cond: **Unknown**
